FOT (Fixed Orifice Tube) Assembly Proper Installation Quality Alert - 3July03

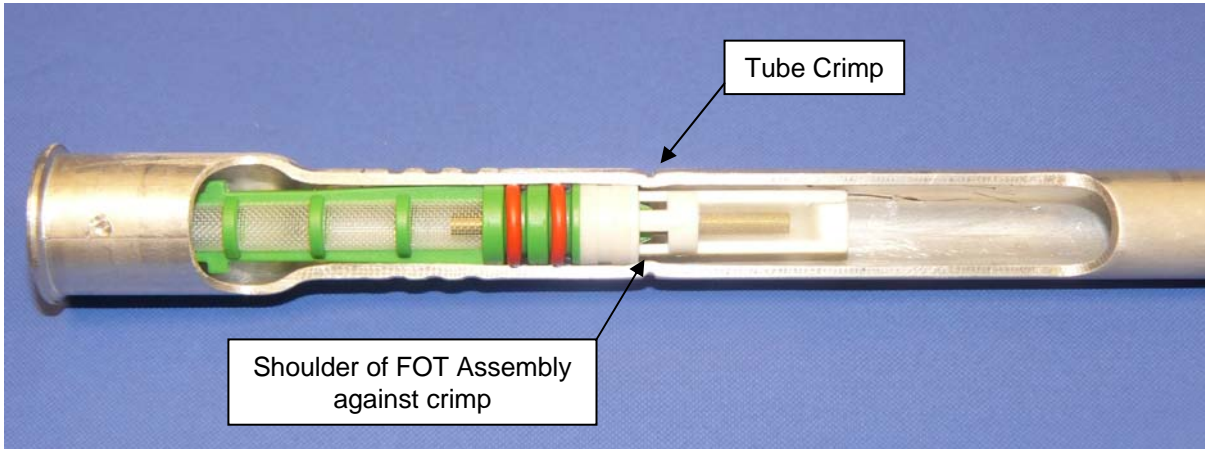
Figure 1: **PROPERLY** seated FOT Assembly against the Aluminum tube crimp.

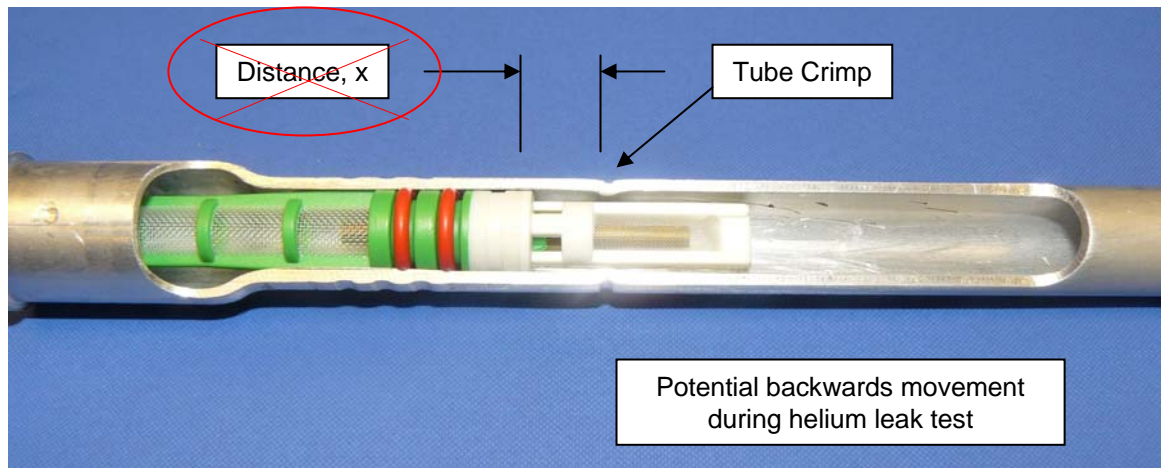
Figure 2: **IMPROPERLY** seated FOT Assembly against the Aluminum tube crimp.

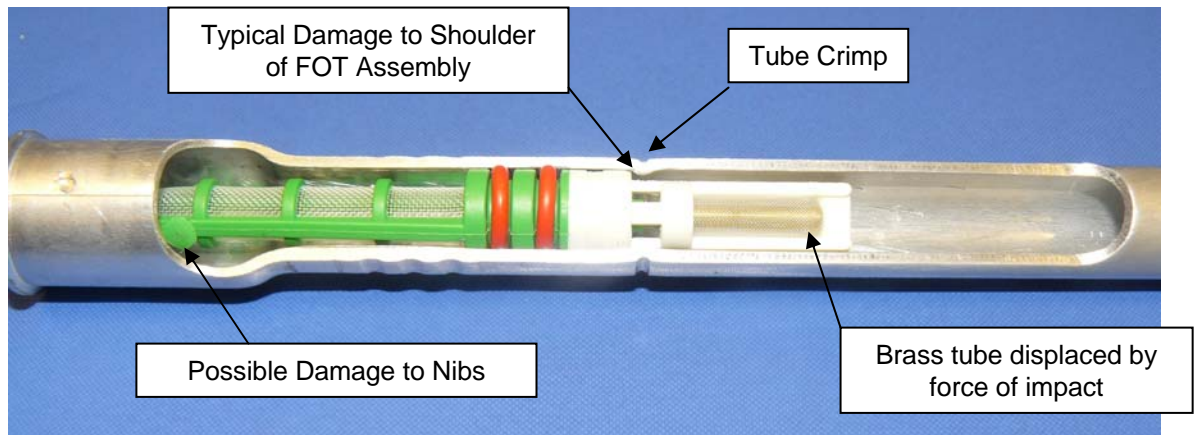
Figure 3: FOT Assembly moves rapidly into the tube crimp during the evacuation and fill process or during high compressor loads and pressure. The brass tube will continue to move out of position. A/C system may not function properly due to flow restrictions.
